BUILDING 2054

CONDITION SURVEY DATA SHEET

CONDITION SURVEY

SHOP

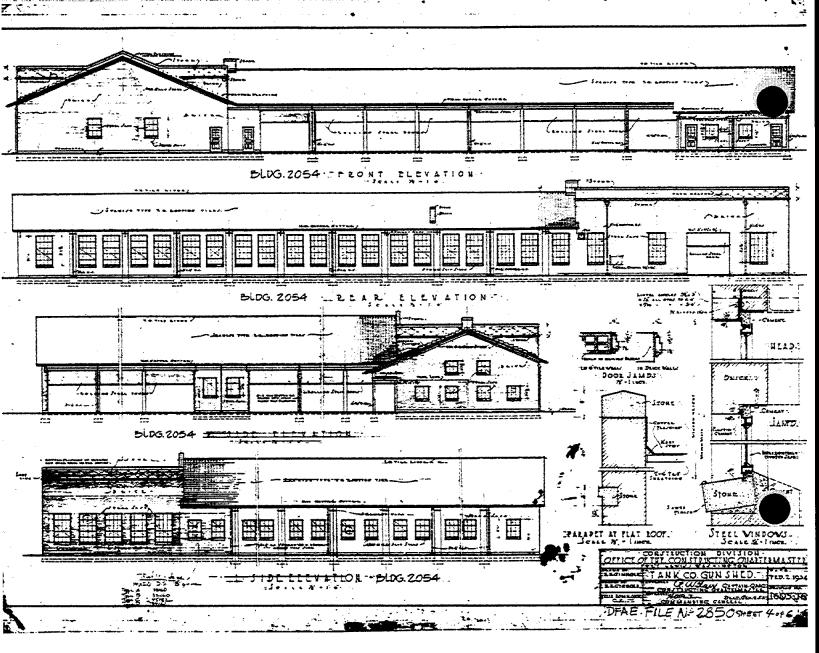
Building 2054 (formerly 311) is a masonry shop building with tile roof and sheet metal soffits. The windows are steel sash with concrete sills.

The building is L shaped and was constructed in 1934. It is the only building with an integral roofed porch at the office entry.
